TECHNICAL REPORT REMR-CO-3

CASE HISTORIES OF CORPS BREAKWATER  
AND JETTY STRUCTURES

Report 9

SOUTHWESTERN DIVISION

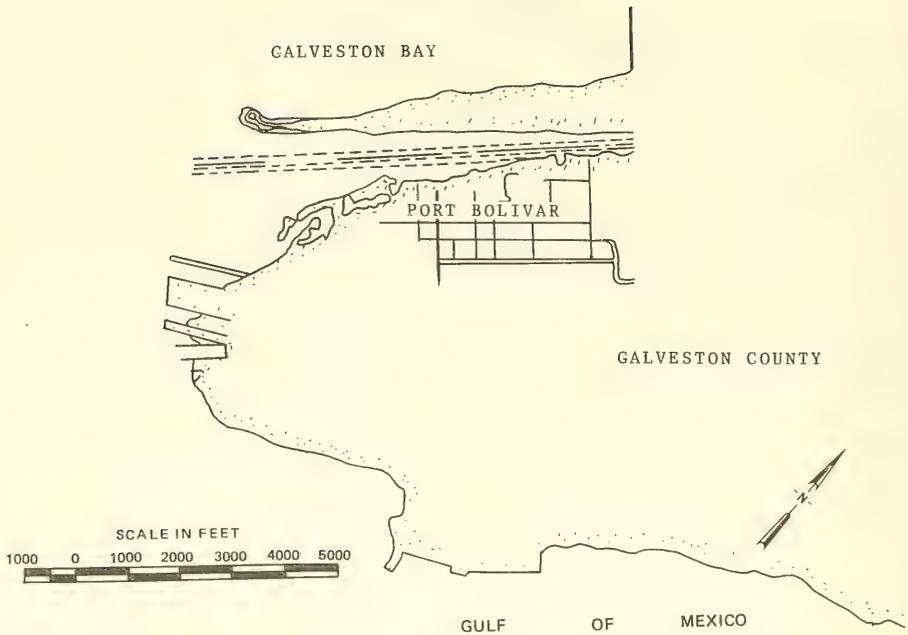
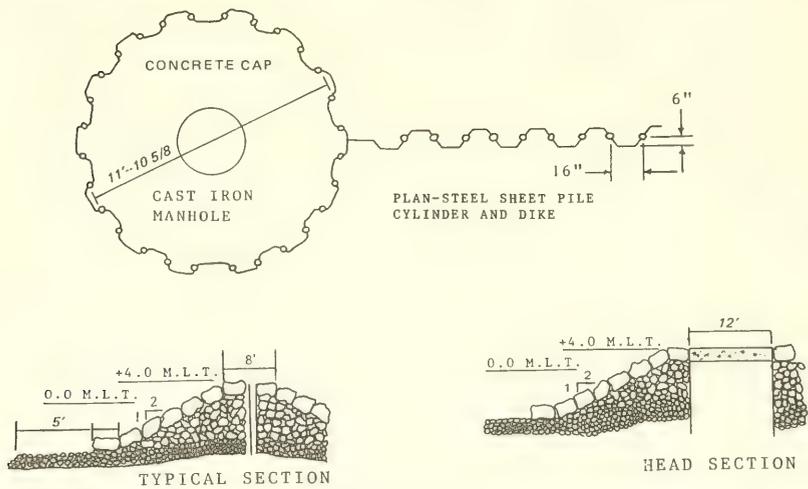
Figure 3. Location, plan view, and typical sections of Port Bolivar jetty

<u>Date(s)</u>	<u>Construction and Rehabilitation History</u>
1933- 1934	A 1,700-ft-long steel sheet-pile dike was constructed to prevent shoaling in the Gulf Intracoastal Waterway at this location (Figure 3). The seaward end of the dike consisted of a 12-ft-diam sheet-pile cell, with a 2-ft-thick concrete cap (and underlying fill material), protected by a stone blanket at the toe of the cell. The top elevation of the sheet pile was +4 ft mlt. Existing water depths varied from -4 (landward) to -13 (seaward) ft mlt. A total of 47,500 sq ft of sheet pile and 6,670 tons of stone was used. Cost of the improvements was \$25,000.
1936- 1937	The landward end of the dike was repaired and extended 200 ft at a cost of \$7,050. Approximately 230 tons of stone was placed as scour protection at the seaward end at a cost of \$1,750.
1966	The outer 1,230 lin ft of sheet pile was supplemented with a rubble-mound section similar to the 1964-1965 Port O'Connor repairs. The dike was generally intact, with some damage to the piling at the outer end and a heavy coating of rust scale due to saltwater exposure. Existing ground elevations varied from -5 ft mlt near the seaward end to +4 ft mlt along the unrepaired landward segment (in general, an accretion of 6 to 8 ft had occurred since original construction). The outer sheet-pile cell, with a maximum water depth of -11 ft mlt, was the only section where localized scour was evident (but in this case not critical to structural integrity). The sheet-pile top elevation was generally from +3.5 to +4 ft mlt (within 0.5 ft of the design elevation). The rubble-mound design sections (Figure 3, inset), with the existing dike at the center line, had a crown elevation varying from +4 (seaward) to +6 (landward) ft mlt, a crown width of approximately 8 ft (2 cover stones wide) and 1V:2H side slopes. The sections were built upon a 2-ft-thick (3 ft at outer end) bedding layer of 0.5-in. to 200-lb stone. The bedding layer extended from 3 ft (landward) to 10 ft (seaward) beyond the toe of the cover layer and was covered with a 2-ft-thick layer of 200- to 1,000-lb apron stone. Similar sized stone were used as core stone, and the outer layer consisted of 1- to 6-ton stone. Filler stone (0.5 to 4 in.) also were placed with the core stone, in a section extending beneath the crown at 1V:1H side slopes. The general purpose of filler stone is to decrease permeability and reduce sediment transport through the structure. The cover stone size was selected based partly on Hudson's slope stability equation and partly for economic reasons. A total of 19,280 tons of stone was placed at a cost of \$164,700.

1985	The dike presently is considered to be in good condition.

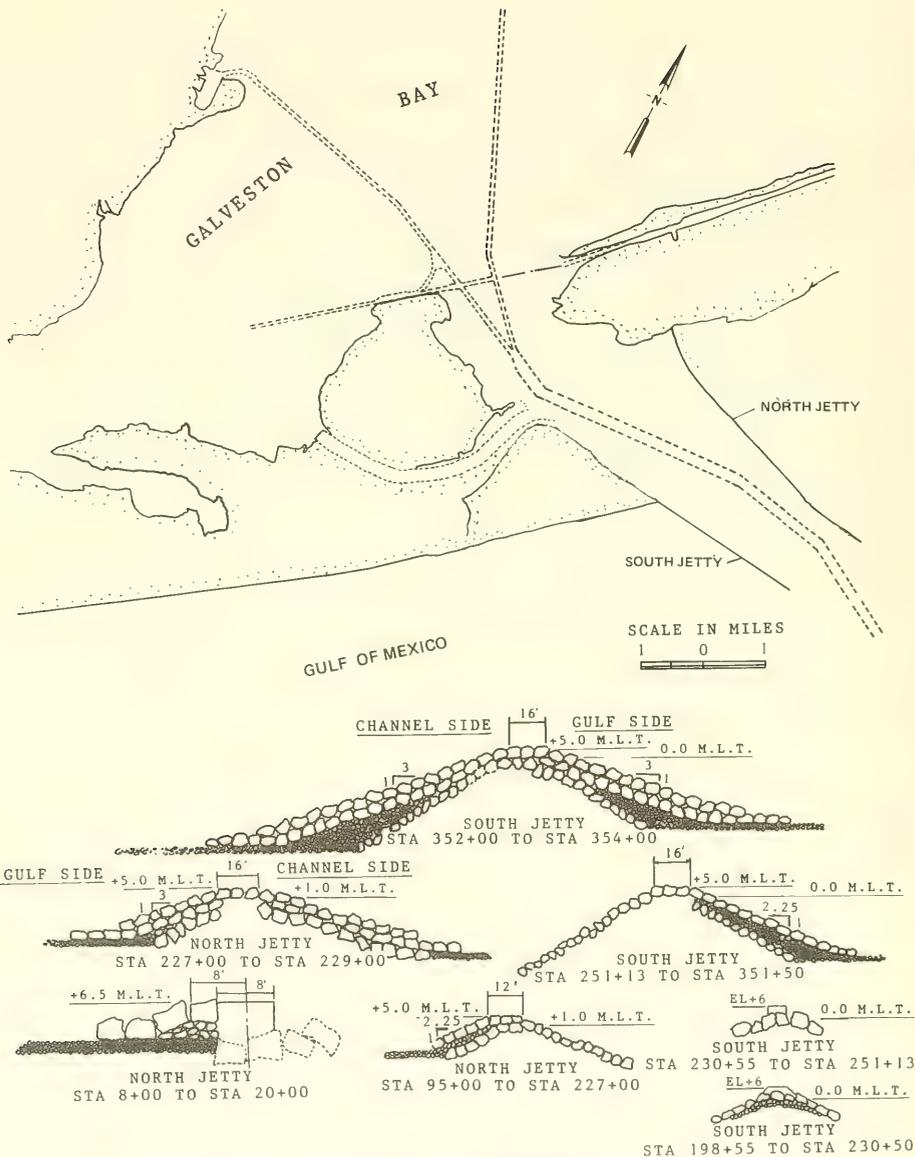
Figure 4. Plan view and typical cross sections of Galveston Harbor jetties

1880- 1885	A second attempt at a south jetty consisted of placing multiple layers of log and brush (fascine) mattress, each layer ballasted with stone riprap. A total of 22,550 lin ft was constructed with as many as four layers placed. The majority of the jetty was submerged with only its landward end above mlt. The mats were typically 1.5 ft thick and 30 to 120 ft wide at the base with narrower mats (15 to 60 ft wide) placed in the remaining layers. Approximately 400,000 sq yd of mattress and 9,000 tons of stone (roughly 50 lb/ft <sup>2</sup> ) were placed at a total cost of \$968,000. By 1885, consolidation of the mattresses, settlement due to scour, and teredo damage had led to general deterioration and an average subsidence of almost 6 ft.
1887- 1898	Rubble-mound jetties were constructed and completed to lengths of 25,600 and 34,800 ft on the north and south sides, respectively (Figure 4). The south jetty was built during 1887-1893 and 1895-1897, and the north jetty was built during 1893-1898. The jetties were placed along the alignments of the earlier jetty attempts (the south jetty rubble mound being placed on top of the remains of the fascine mat jetty (from sta 84+64 to sta 310+14)), converging in the offshore direction to a distance of 7,000 ft. The jetties were built to +5 ft mlt, a typical crown width of 12 ft (but as large as 20 ft at the seaward end of the south jetty), and as steep as practicable side slopes (typically 1V:1H and up to 1V:1.5H at the seaward ends). The majority of the jetties were constructed using sandstone riprap varying in size from 20 lb to 3 tons. Granite blocks, varying in size from 0.75 ton to 10 tons and more, were used as the cover layer

Date(s)	Construction and Rehabilitation History
1962- 1966 (cont.)	<p>(Figure 4). The outer 200 ft on each jetty was built as a head section with stone placed over the entire cross section. The design geometry was positioned 4 ft gulfward of the existing jetty center line with a top elevation of +5 ft mlt, a 3-stone-wide crown, and side slopes of 1V:2.25H and 1V:3H on trunk and head sections, respectively. The sections were built upon a 2- to 3-ft-thick blanket of 0.5-in. to 200-lb stone. The blanket extended beyond the cover layer toe distances of 10 and 50 ft for trunk and head sections, respectively. Core stone, typically 200 to 2,000 lb in size, then were placed providing the necessary side slope. One layer of cover stone was placed, except on the head sections, which used a double layer. Cover stone varied from a maximum of 16 to 18 tons at the heads to minimums of 2 and 6 tons at the north and south jetty landward ends, respectively. To decrease jetty permeability, 0.5- to 4-in. filler stone was placed in the crown area beneath the cover layer. Prior to the repairs, the jetties were in a general state of deterioration with much of the south jetty and several spots of the north jetty at or below +3 ft mlt. In many cases core stone was exposed, or cover layer stone was not tightly interlocked. Due to these conditions and use of large core stone during original construction, the jetties were considered too pervious to wave, tide, and sediment motions. Scour on the channel side of the north jetty was evident from sta 50+00 to sta 190+00 where the authorized 30-ft-deep channel made its closest approach to either jetty. Along this section water depths were typically 40 ft or greater within 100 ft of the jetty center line, while on the gulf side the typical water depth was 10 ft. This was a major reason for repairing the gulf side of the north jetty, since the quantity of stone required would be much smaller. The total costs for rehabilitation of the north and south jetties were \$3,440,000 and \$2,564,500, respectively. Although data on complete stone quantities were not found, partial quantities and several similar construction or repair projects (with known stone quantities) built during this time frame yield an estimate of from 600,000 to 1,200,000 tons of stone placed.</p>

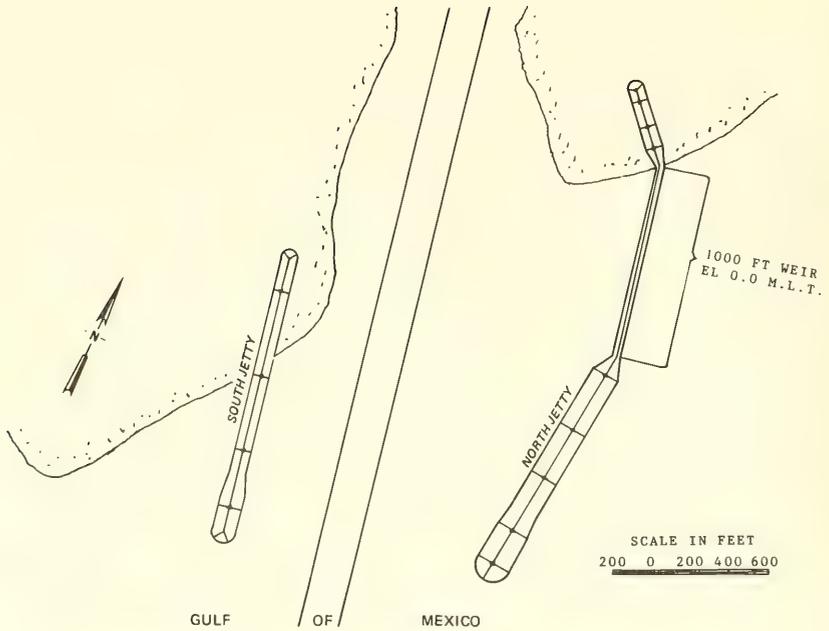
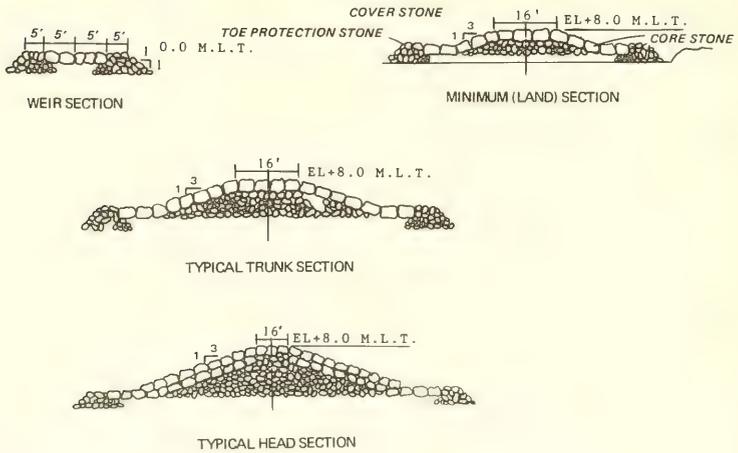
Figure 7. Plan view and typical cross sections of Colorado River jetties

Date(s)	Construction and Rehabilitation History
1984- 1986	<p>As part of navigational improvements, two rubble-mound jetties were constructed at the mouth of the Colorado River (Figures 6 and 7) providing protection for the 15- by 200-ft entrance channel. The south jetty is 1,450 ft long, and the north jetty, which contains a rubble-mound weir, is 2,650 ft long. The north jetty weir section begins 410 ft from landward end, at about the mlt contour, and extends 1,000 ft seaward to about the -8 ft mlt contour. The seaward ends of the north and south jetties are about 1,800 ft apart and situated in water depths of approximately -12 and -5 ft mlt, respectively. The jetty design incorporated an impoundment basin on the channel side of the north jetty to trap littoral drift material passing over the weir. The basin, initially dredged to a capacity of 740,000 cu yd, will be dredged periodically and the material deposited downdrift of the jetties. The crown elevations of the weir section and remaining jetty sections are 0 and +8 ft mlt, respectively. The design crown width and side slopes are 16 ft and 1V:3H, respectively. The typical jetty trunk section (Figure 7) consisted of a 2- to 3-ft-thick bedding layer of 0.5-in. to 200-lb stone, 200- to 1,000-lb core stone (2,000-lb maximum on the seaward leg of the north jetty), and a single layer of rectangular granite cover stone. The 200-ft-long head sections (at the seaward ends) were similar to the trunk sections except for a double layer of cover stone on the side slopes and a 5-ft-thick bedding layer on the north jetty. The cover stone varied in size from 4 to 6 tons at the landward ends to maximums of 16 to 18 tons and 10 to 12 tons at the seaward ends of the north and south jetties, respectively. To buttress the armor layer at the slope toes, the outer two to three cover stones were to be placed horizontally on the bedding layer. Cover stone sizes were selected using design wave heights of up to 17.6 ft (north jetty head) and Hudson's slope stability formula. The permeability of the jetties was decreased by chinking a section of the core stone, extending the full width of the crown and downward on 1V:1H slide slopes, with 0.5- to 4-in. filler stone. The absence of a core stone section was the only difference between the weir and trunk sections. Toe protection stone was placed on all sections of the jetties, buttressing the bedding layer and outermost cover stone (thus the thickness varied from 5 to 9.5 ft). The width of the toe protection section was 5 ft except on the head sections where it was 10 ft, and the design outer side slope was 1V:1H. The stone size was the same as the adjacent core stone (weir section used 200- to 2,000-lb stone). Transition sections, 100 ft long, were provided for changes in grade (or stone geometry) among weir, trunk, and head sections. Approximately 490,000 cu yd of material from the channel and deposition basin were to be used as fill on the west side of the channel and shoreline</p>

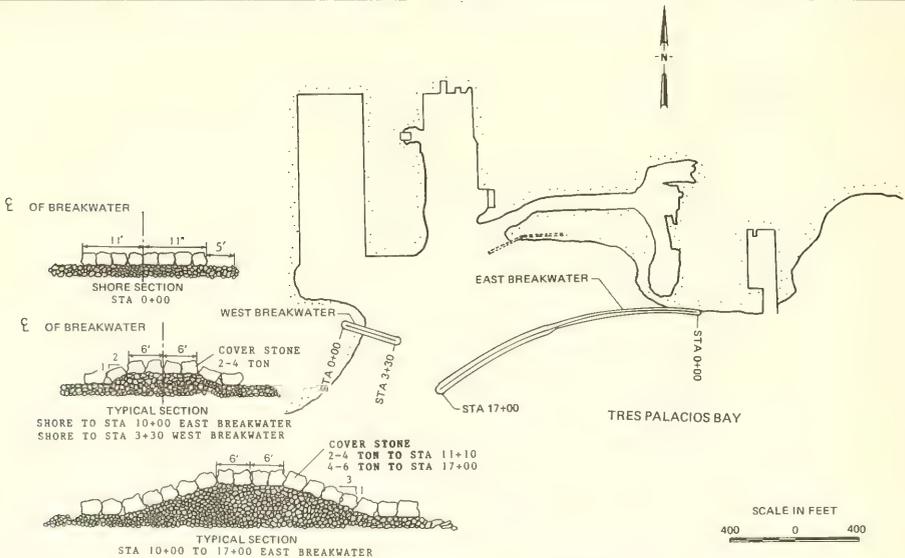
Figure 8. Plan view of Palacios Harbor and typical breakwater cross sections

Date(s)	Construction and Rehabilitation History
1966	Two rubble-mound breakwaters were constructed to lengths of 1,700 and 330 ft on the east and west sides, respectively, of the Palacios channel entrance (Figures 6 and 8). The purpose of the structures was to reduce wave energy entering the harbor and shoaling in the harbor slips and entrance channel. The breakwaters were constructed with a core and 2-ft-thick bedding layer of 0.5-in. to 200-lb stone. The core stone was placed to an elevation of +2 ft mlt, a width of 12 ft, and side slopes of 1V:3H and 1V:2H on the outer 700 ft of the east and remaining breakwater sections, respectively. A single layer of 2- to 4-ton cover stone was used on the breakwaters, with the exception of the outer 590 ft of the east breakwater which was covered with 4- to 6-ton stone. Some toe protection was provided by placing one to two cover stones at the base of the side slopes and extending the bedding layer 5 ft beyond the cover stone.

1970	The shoreline, made up of clay banks, was eroding in the general vicinity of the west breakwater. Rubble stone was placed along the shoreline on either side of the breakwater. (No details are available.)
1983	The breakwaters were inspected and considered to be in good condition.

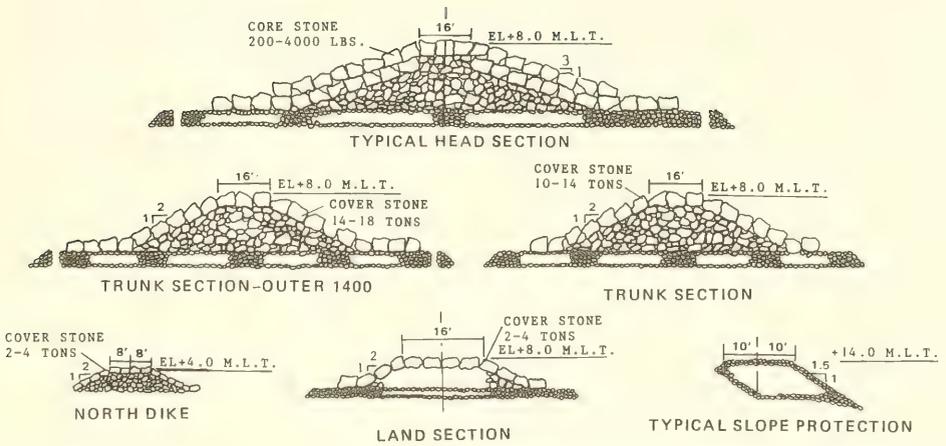
Figure 10. Typical cross sections of Matagorda Ship Channel jetties

Date(s)	Construction and Rehabilitation History
1963- 1966	<p>As part of the Matagorda Ship Channel project, twin rubble-mound jetties were constructed from Matagorda Peninsula into the Gulf of Mexico (Figure 6). The east and west jetties were 5,900 and 6,000 ft long, respectively, spaced 2,000 ft apart, and terminated at approximately the -24 ft mlt contour. The jetties provide protection for the 38- by 300-ft entrance channel. The design cross sections (Figure 10) consisted of a 16-ft crown width at +8 ft mlt and side slopes of 1V:2H and 1V:3H on the trunk and head sections, respectively. The head section on each jetty was 200 ft long, followed by a 100-ft-long transition tying into the trunk section. The typical jetty cross section was built on a bedding layer of 1/2-in. to 200-lb stone, varying in thickness from 2 ft at the landward end to 5 ft at the seaward end. To provide scour protection, the bedding layer extended beyond the toe of the cover stone a minimum of 5 ft at the landward ends to a maximum of 50 ft at the seaward ends. The core was built using 200- to 4,000-lb stone (except the landward 600 to 700 ft of the jetties which had a maximum stone size of 1,000 lb). To prevent the flow of littoral drift through the jetty, a section of the core (extending below the width of the crown at 1V:1H side slopes) was made impervious by adding 1/4- to 4-in. filler stone. A single layer of cover stone was placed on the jetty trunk sections, and a double layer of cover stone was placed on the head section side slopes. The outermost two to three cover stones were placed horizontally on the bedding layer, in effect buttressing the armor stone layer. The rectangular granite cover stone varied in size from 2 to 4 tons at the landward ends and 16 to 18 tons at the seaward ends. Cover stone sizes were selected using Hudson's slope stability formula, design wave heights of 10 to 22.6 ft, and a +13 ft mlt surge level. Under these conditions and no-damage criteria, calculated stone sizes ranged up to 48 tons. The largest available stone was less than 20 tons. Thus, the design used a stability coefficient of 6.8, allowing for a 10 to 20 percent damage level. The underlying foundation materials are mostly fine sands with some shell to a depth of about -60 ft mlt. During jetty construction the channel through the peninsula had progressed to the point that only a narrow earthen plug on the gulf side remained. On the night of 24 September 1963 the earthen plug was breached by a high tide in the gulf, and the resulting tidal currents soon caused severe erosion and scour at the outer ends of the partially completed jetties. The natural depths at the outer ends of the jetties were about -15 ft mlt prior to the breach but within a short period increased to about -40 ft mlt, during which time jetty construction was interrupted. The remaining jetty sections were completed under a new contract starting in 1964. Construction of the jetties, a north dike, and channel revetments totaled \$13,200,000 using approximately 2,000,000 tons of stone.</p>

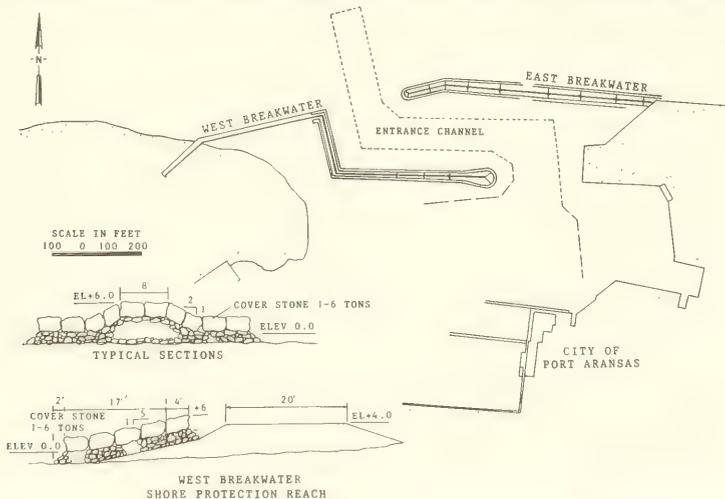
Figure 12. Port Aransas plan view and typical breakwater sections

Date(s)	Construction and Rehabilitation History
1973	Two rubble-mound breakwaters, the east 850 ft long and the west 1,290 ft long, were constructed to provide adequate protection from ship-generated (Corpus Christi Channel) and wind-generated waves entering the existing anchorage basin at Port Aransas (Figure 12). The typical cross section geometry (Figure 12) had a crown elevation of +6 ft mlt, an 8-ft crown width, and 1V:2H side slopes. Cover stone size was 1 to 6 tons. The core and 2-ft-thick bedding layer were made up of 0.5-in. to 200-lb stone. The landward 550 ft of the west jetty were constructed as a sand-fill dike, with a crown elevation of +4 ft mlt and a top width of 20 ft. A 21-ft-wide section of its 1V:5H seaward side slope was revetted with a 2-ft-thick bedding layer and cover stone layer (Figure 12). The revetted section was aligned with the breakwater section so that the tops were coincident at the harbor side of the crown width. The center line of the fill section was about 16 ft behind this point. The cover stone size was selected based on the lower cost of placing the 1- to 6-ton stone versus the 700- to 800-lb stone size required for slope stability (design waves of 8.7 ft and Hudson's formula). The breakwaters were constructed on a foundation of sands and silty sands.

1977	An inspection of the breakwaters indicated they were in good condition with the exception of the revetted section of the west jetty. Waves breaking over the shore protection had eroded the sand fill resulting in some minor settlement of the stone.
1984	The breakwaters were inspected and considered to be in good condition.

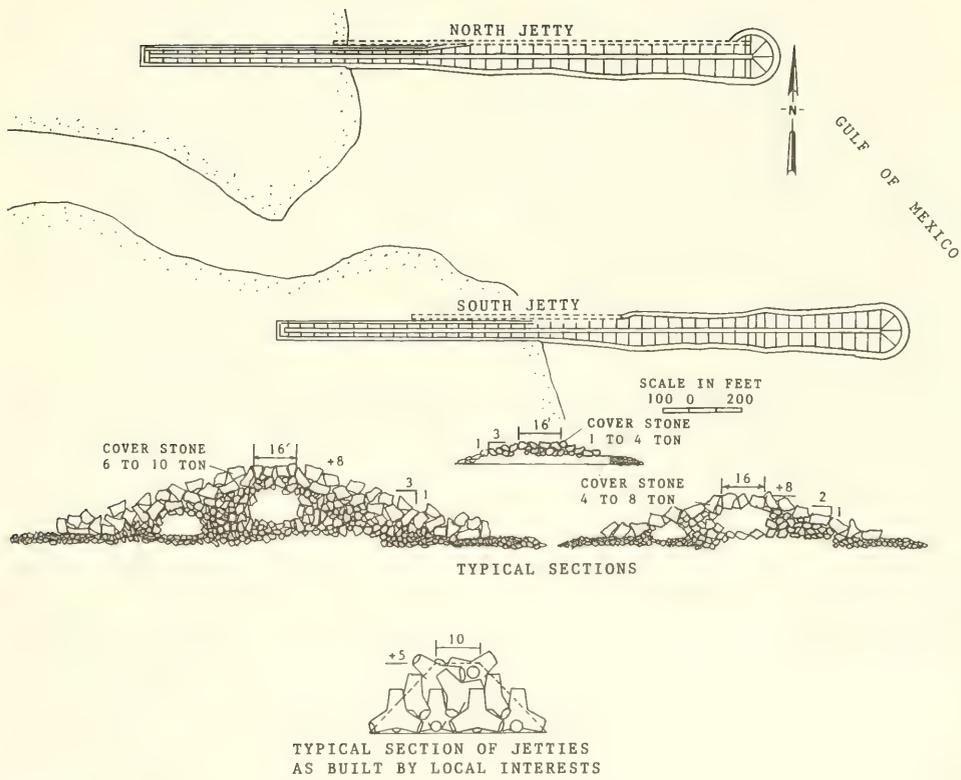
Figure 13. Plan view and typical cross sections of Port Mansfield jetties

Date(s)	Construction and Rehabilitation History
1957- 1961	<p>Local interests dredged a channel across Padre Island and constructed two tetrapod jetties at the entrance to the Gulf of Mexico. The north and south jetties were 1,600 and 800 ft long, respectively, and spaced 1,000 ft apart (Figure 13). The tetrapods weighed 5, 8, and 16 tons each and were placed directly on the existing bottom to a cross section of +5 ft mlt, a 10-ft top width, and 1V:1H side slopes (Figure 13, inset). Within a year these jetties were no longer providing adequate channel protection. The tetrapods had subsided, the shore ends were in water 2 to 4 ft deep, scour channels existed along sections of both jetties, and extensive shoaling had occurred in the entrance channel. By 1961 the inlet had closed and the tetrapods were nearly submerged.</p>
1962	<p>Two rubble-mound jetties were constructed under Corps management and Federal funding as part of navigational improvements between Port Mansfield and the Gulf of Mexico (Figure 13). The north and south jetties (2,300 and 2,270 ft long, respectively) were constructed on the south sides of the existing tetrapod jetties. The parallel jetties, spaced 1,000 ft apart, terminated at approximately the -9 ft mlt contour. The jetties were staggered with the south jetty 490 ft east of the north jetty. The design geometry (Figure 13, inset) consisted of a +8 ft crown elevation, 16-ft crown width, and 1V:3H side slopes. The cross section was built on a 3-ft-thick bedding layer of 0.5-in. to 200-lb stone. The bedding layer was to extend beyond the ends of the cover stone layer, typically 2 ft at the landward ends to 15 ft at the seaward ends. The core was built up using 200- to 1,000-lb stone along landward sections (each several hundred feet long) and 200- to 4,000-lb stone along the remaining seaward sections. Jetty permeability was decreased by supplementing a mid-section of the core with 0.5- to 5-in. filler stone. The geometry of this combined core stone extended below the full crown width at 1V:1H side slopes. The cubically shaped granite cover stone increased in size from 1 to 10 tons, between landward and seaward ends of each jetty, respectively. The seaward 100 ft of each jetty had an additional layer of 6- to 10-ton cover stone placed on the side slopes. Stone sizes were selected using Hudson's slope stability formula and depth-limited wave heights of up to 12 ft at the seaward ends (+6 ft mlt surge level). The foundation for the jetties consisted of various sand and clay layers, including a 10- to 15-ft-thick layer of soft clay. Soil tests indicated that the clay layer could consolidate up to 0.75 ft (seaward end), and total structure settlement on the order of 3 ft was expected (consolidation of the foundation and jetty materials). Total cost was \$2,736,000 with 307,030 tons of stone placed and 10,000 tons of blanket stone stockpiled.</p>

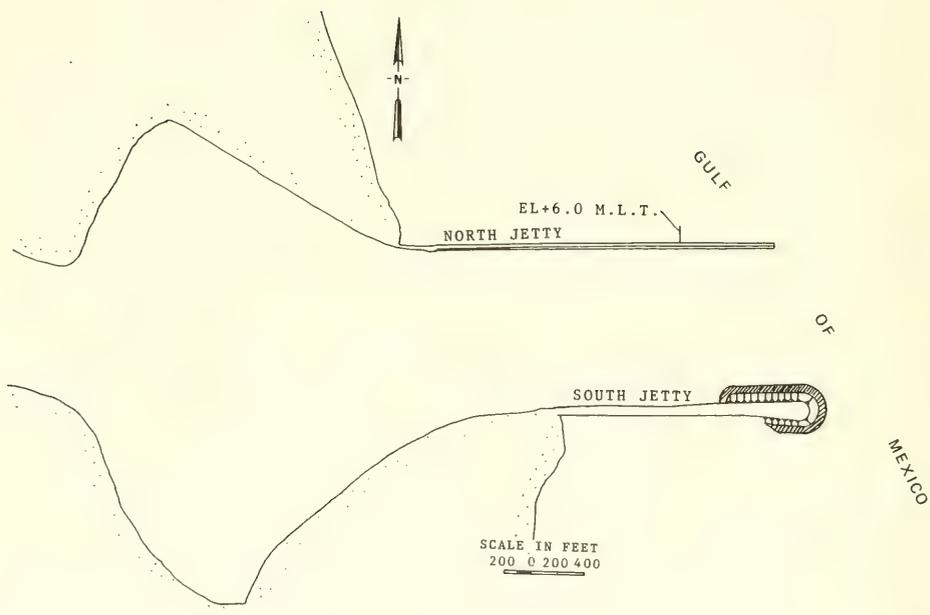
Figure 14. Plan view of Brazos Island jetties

1933- 1935	The existing jetties (Figure 14) authorized by the River and Harbor Act of 1930 were constructed near the locations of the 1926-1927 stone dikes to lengths of 5,370 and 5,092 ft on the north and south sides, respectively. The jetties converge from their landward ends to a spacing of 1,200 ft then run parallel for approximately 2,500 ft, terminating at the -25 ft mlt contour. The typical cross section consisted of a 14-ft crown width at +6 ft mlt, 1V:1.5H side slopes, a riprap bedding layer, 15- to 4,000-lb core stone and 6- to 10-ton capstone. The jetties were constructed with 418,200 tons of stone at a total cost of \$2,741,000.
1936- 1937	Stone aprons were placed near the outer ends of both jetties. No details are available. Riprap stone totaling 7,400 tons was placed at a cost of \$47,000.
1940- 1943	Various sections of both jetties totaling 5,690 lin ft were repaired using new core and cover stone and resetting existing cover stone. Approximately 20,800 tons of new stone were used and 1,570 stones reset for a total cost of \$244,100.

1954- 1955	The jetties were repaired using new core and 8- to 16-ton cover stone, resetting existing cover stone, and capping with concrete. The concrete was placed above mlw throughout the void spaces in the cover layer, restoring the general crown elevation of the jetties. Total cost of the repairs was \$859,000 using 20,300 tons of stone and placing 6,160 and 3,580 cu yd of concrete on the north and south jetties, respectively. The concrete capping extended from the existing shoreline to the jetties' seaward ends (roughly 3,000 lin ft on the north and 2,000 lin ft on the south).
